MANN+HUMMEL FM600 Oil Cleaning Centrifuge Maintenance Procedure

Applicable for the FM600-21/22/23/24/25/26/39 series Centrifuge Range

OIL CONDITIONING SYSTEMS SPARE PARTS LIST

FM600 - 21/22/23/24/25/26/39 SERIES

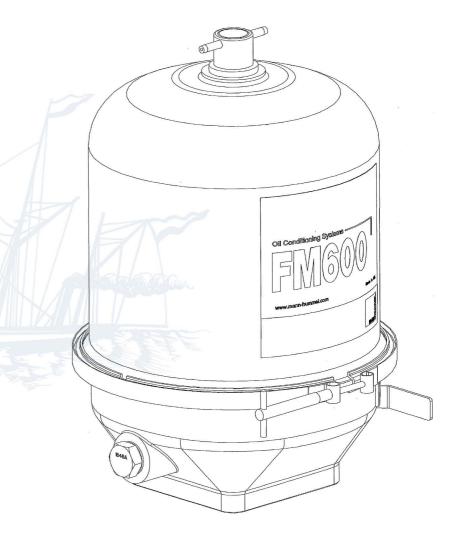
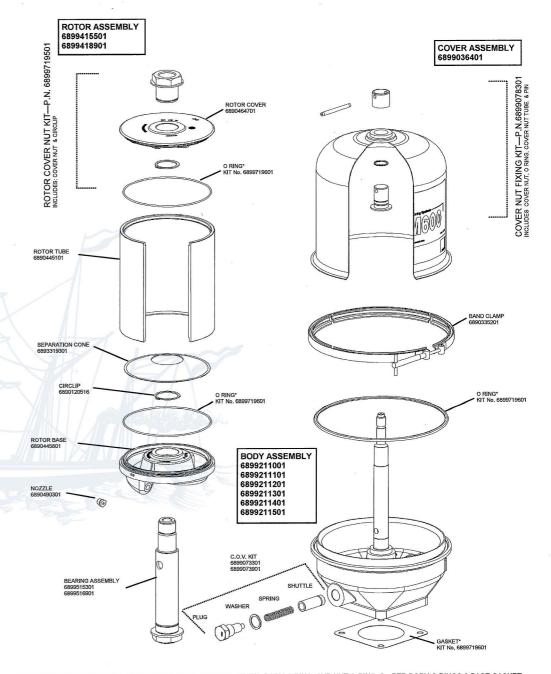
Spare Parts List

CRACOO	PART No.	QTY	FM600-21	FM600-22	FM600-23	FM600-24	FM600-25	FM600-26	FM600-39
FM600			(6899118701)	(6899118801)	(6899118901)	(6899119001)	(6899119201)	(6899119301)	(6899123501
CUT OFF VALVE RATING BAR)				3.5	2.5	2.5	2.5	2.5	3.5
DIL INLET THREAD SPEC.			3/4" BSP	3/4" BSP	3/4" BSP	1 ⁵ / ₁₆ " UNF	3/4" NPT	M27x1.5	3/4" BSP
BODY ASSEMBLY	6899211001	1	•						
	6899211101	1		•					•
	6899211201	1			•				
	6899211301	1				•			
	6899211401	1					•		
	6899211501	1						•	
OTOR ASSEMBLY	6899415501	1		•	•		•	•	
	6899418901	1		-	_				
OZZLE	6890490301	2	•	•	•	•	•	/•/	
EARING TUBE ASSEMBLY	6899515301	1	•	•	•	•	•	/•/	ZAI)
EARING TUBE ASSEMBLY	6899516901	1					//	Yes	4 0€
EPARATION CONE	6893319301	1	•	•	•	• /	/ •	/•>	/ I.
IRCLIP	6890120516	1	•	•	•	-	•/		///I
APER INSERT (NOT ILLUS- RATED)	6890302801	1	•	•	• /	•	/•/		///•i1
OTOR TOP	6890464701	1	•	•	•	• /	/•/	∕• 777	- J
OTOR BASE	6890445801	1	•	•	•//	•	/ • /	•///	•
OTOR TUBE	6890445101	1	•	•	•	1	•	_/•///	•

OVER ASSEMBLY	6899036401	1	•.	•	• ·			•	•
OVER SUB-ASSEMBLY	6899061901	1							
	000000								
SAND CLAMP	6890335201	1	•	•	•	•	•	•	•
M600 KITS	PART No.	QTY	FM600-21	FM600-22	FM600-23	FM600-24	FM600-25	FM600-26	FM600-39
UT OFF VALVE KIT			(6899118701)	(6899118801)	(6899118901)	(6899119001)	(6899119201)	(6899119301)	(6899123501
UT OFF VALVE KIT	6899073301	1		•					•
OVER NUT FIXING KIT	6899073901	1			•	•	•	•	
OTOR COVER NUT KIT	6899078301 6899719501	1	•	•	•		•	•	•
EALS KIT	6899719601	1	•	•	•	•	•		-

*SEALS KIT P.N. 6899719601 COMPRISES OF: C.O.V. WASHER, FILTER BODY O RING, CVR NUT O RING, 2 x RTR BODY O RINGS & BASE GASKET
